Quainton Conservation Area

**Quainton
Conservation
Area Review
2015**

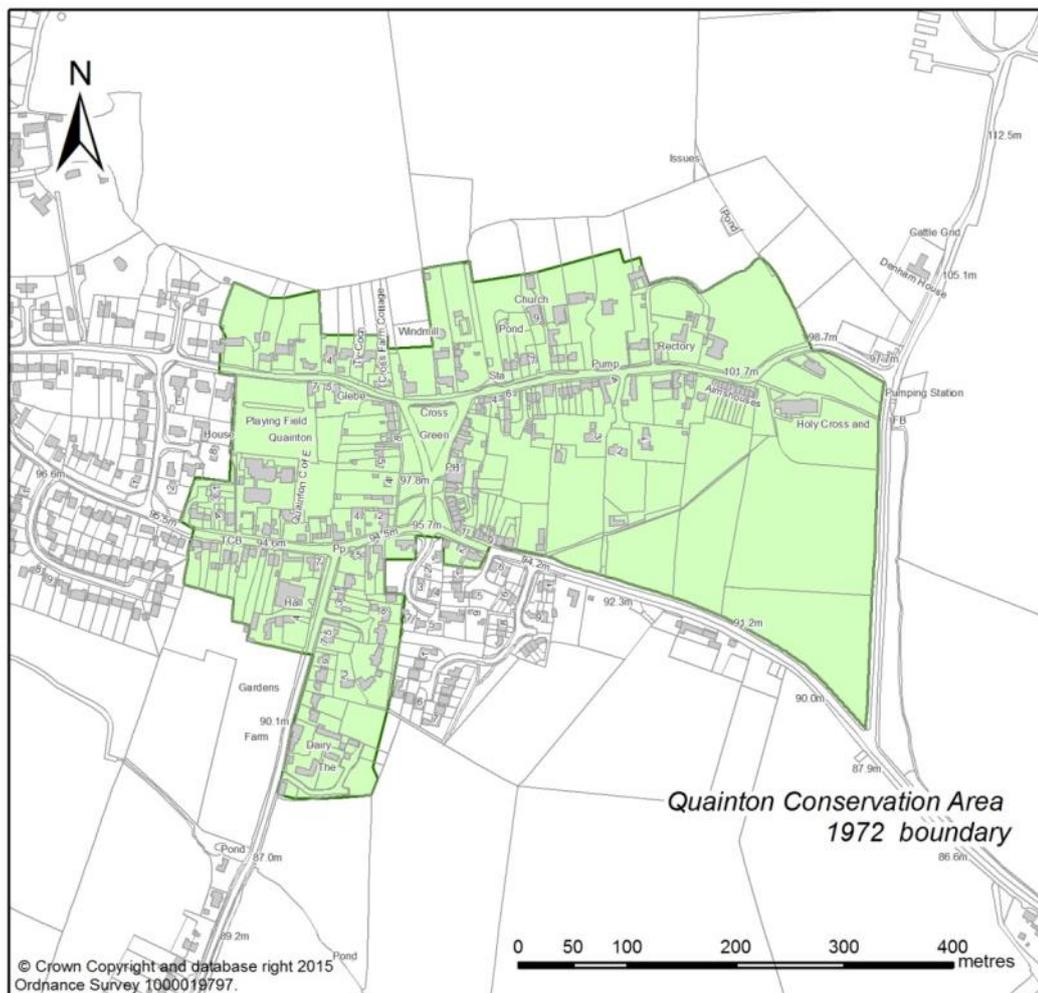
A Conservation Area was designated in Quinton in 1972. It has not been reviewed since. Conservation Area designations must be reviewed from ‘time to time’ in order to ensure that they are still appropriate, and that the designated Conservation Area boundaries are up to date. The plan below shows the original 1972 Conservation Area boundary in Quinton.

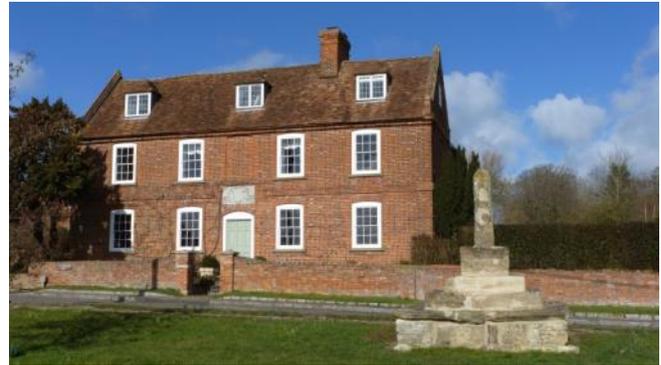
Grade II* listed 12, The Green and remains of 15th century stone cross

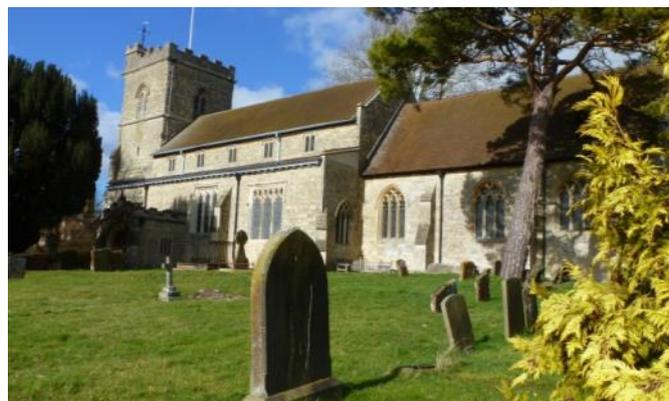
Holy Cross and St. Mary's Church

The church in Quainton is the oldest surviving building within the village. Physical evidence suggests the church dates from c.1340, but documentary evidence dating from the early 13th century in the form of a list of rectors suggests that there may have been an earlier church on the site.

a poor state of repair. During the 1870s the church was heavily restored under the supervision of William White.

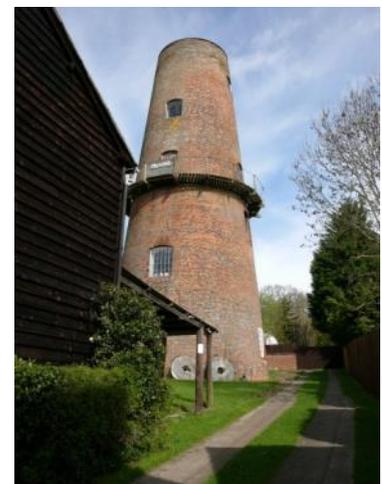
The 19th century also saw the construction of arguably the most iconic structure in Quainton – the Quainton Windmill which is located at the northern end of The Green. The building, at 65 feet (c.20 metres) in height is the tallest tower mill in Buckinghamshire. It was built in 1830 from bricks that were made from clay dug up from pits located a short distance to the north of the mill. The mill was abandoned in 1881 and fell into disrepair. In 1975 it was restored by the Quainton Windmill Society.

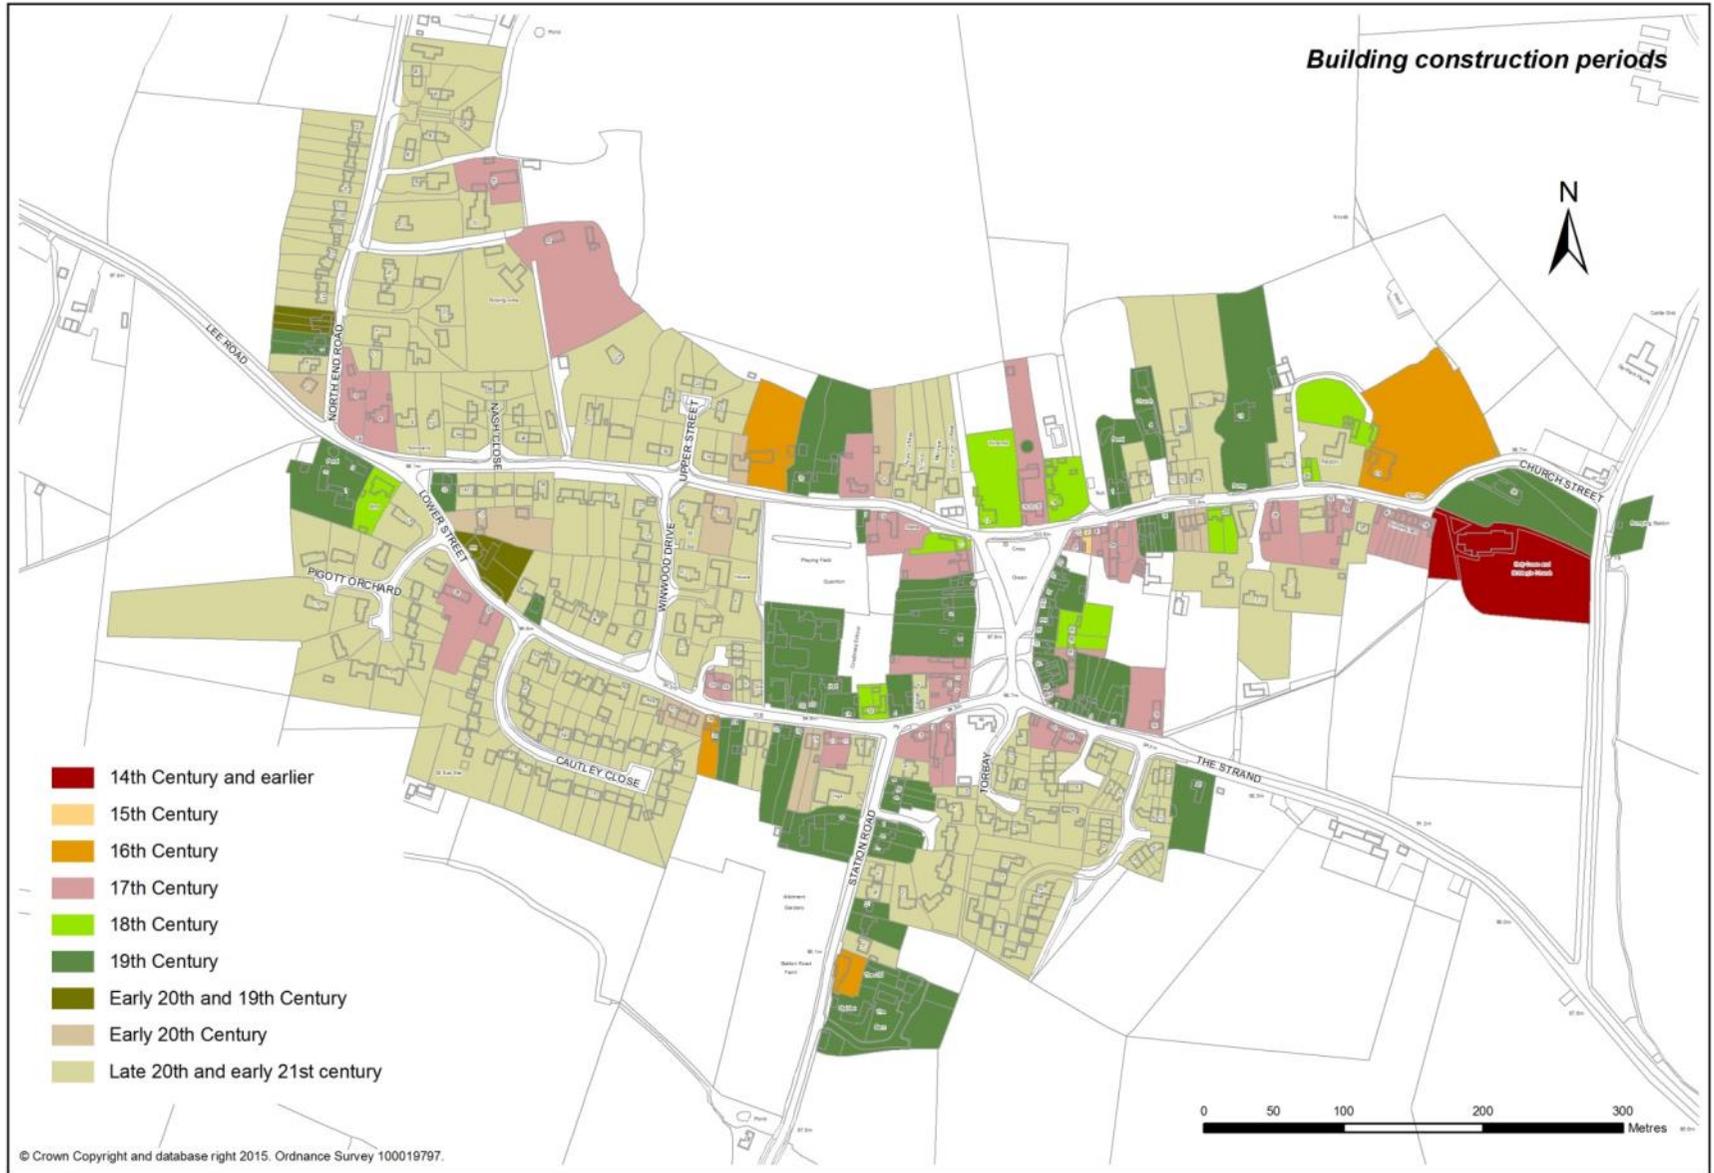
The plan on the next page shows the earliest surviving period of construction of each building within Quainton. It is acknowledged that many of these dates are conservative, as most buildings were not surveyed internally at the time of listing.

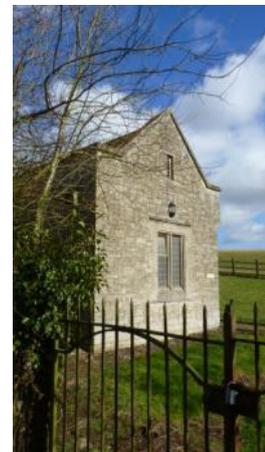
Pumping station

To the east of the church is a small pumping station which is partially obscured from view by hedging. This attractive stone building with its slated gabled roof and stone mullion windows sits well within its rural context and makes a positive visual contribution to the character and appearance of the road and to the setting of the church.

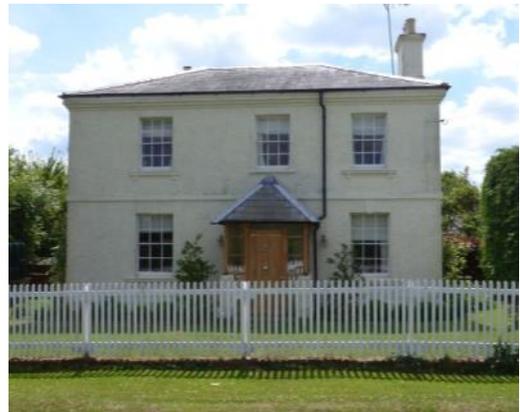
20, The Strand

The Conservation Area boundary has been extended to include 20, The Strand, which was the former police house. This late 19th or early 20th century detached building is prominently situated slightly back from the road edge behind a wooden fence. Now converted to a private domestic dwelling, the building retains much of its original character and a cell still survives within the garden. This building is significant because of the positive visual contribution it makes to the character and appearance of the area as well as to our understanding of the social history of the village.

<p>Local Heritage Asset</p>	<p>Late C19 detached building prominently situated at the eastern entrance to the village. Formerly a police house, a cell still survives within the garden. Visually attractive building set slightly back from the road edge behind a wooden fence. Two storeys with shallow pitched hipped roof laid in slate. Chimney stack to right hand (facing) gable. Regular principal elevation with central doorway contained within a hipped porch flanked to either side by windows. Three windows above. All windows are modern replacements. The building is rendered.</p>

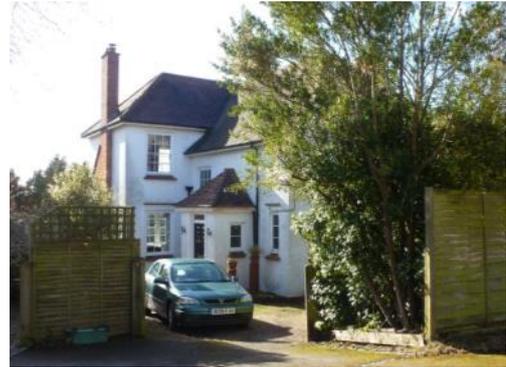
The buildings differ greatly in scale. 17, Upper Street is a substantial Edwardian building which is shown on historic maps of the village as having been located within sizable grounds. The plot has subsequently been subdivided and developed. The principal elevation of this large two storey building faces away from the road, to take advantage of the magnificent views to the south. The building is significant because it retains much of its original external character and is a relatively high status example of Edwardian development within the village. The subdivision of the grounds of 17, Upper Street, marked the beginning of substantial modern development along Winwood Drive.

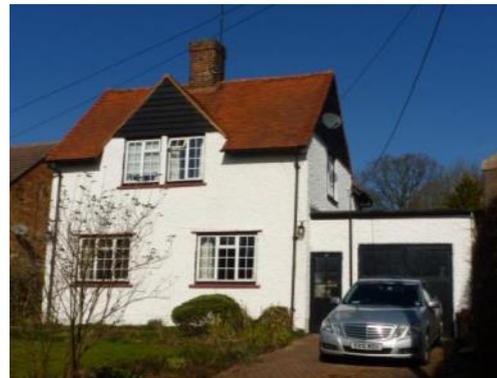
In contrast 14, Upper Street is a much more modest building. It forms a pair with 4 Upper Street which sits within the 1972 Conservation Area boundary. Situated slightly back within its plot, but above the height of the road, this is a visually prominent building which despite some later alterations has maintained much of its original form, scale, massing and character and makes a positive visually contribution to the streetscape.

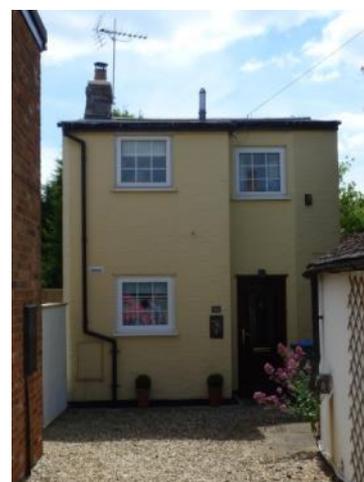
33, Lower Street is set back behind 35, Lower Street and is thought to have functioned as a subsidiary building to it

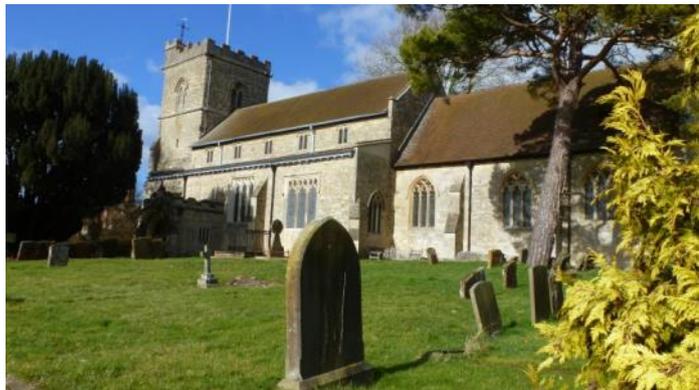
Holy Cross and St. Mary's Church is a very significant building within Quainton, being not only the oldest, but also historically the main focus to the spiritual and social life of the village. The church is constructed from coursed rubblestone. The earliest surviving architecture within the

church dates from the 14th century although documentary evidence would suggest that there was a church on this site during the 13th century. Alterations were made to the church over the succeeding centuries, but by the 19th century, the building was in

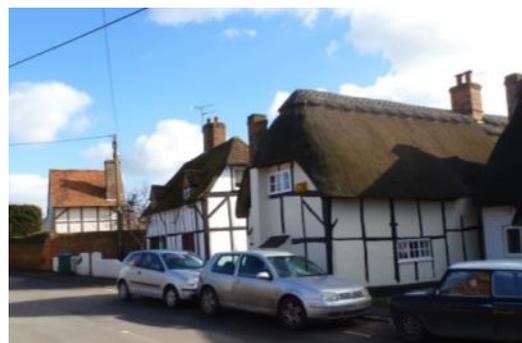
Thatched cottages of 17th century origin on Lower Street

Buildings within Quainton dating from or pre the 17th century are typically one and a half to two storeys in height. They are detached or semi-detached and generally located towards the front of their plots with their ridgelines running parallel with, or gable onto, the carriageway. Roofs are typically gabled and many retain their thatch. Those that have lost their thatch and are now laid in tiles still retain evidence of their former covering in the steepness of their pitches. Window openings of 17th and pre-17th century buildings tend to be small in relation to wall surface and fenestration patterns are generally irregular.

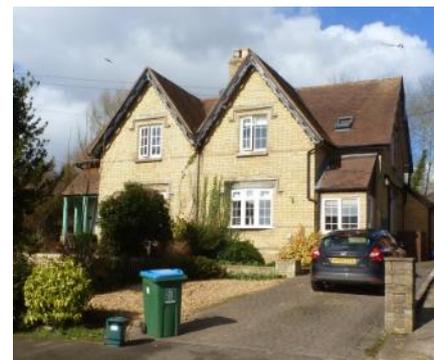
1 and 3, Church Street are of particular note because they are the only surviving example of estate style cottages within the village. This type of building style can be found throughout the Vale and represents a movement during the 19th century towards philanthropic landowners providing better quality housing for their estate workers. Particularly fine examples of this practice can be seen at Waddesdon, which is located a couple of miles to the south of

Quainton, where the Rothschild family rebuilt most of the original village. Estate cottages tend to be characterised by plan forms of varying complexity, steeply pitched gabled roofs, usually laid in tile, prominent chimney stacks, the use of a variety of construction materials and decorative architectural detailing. The estate cottages at Church Street, are relatively modest in their scale and detailing, but are nevertheless clearly recognisable as belonging to the estate building type.

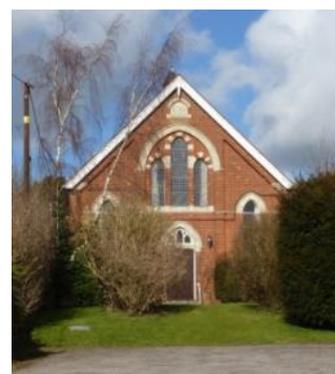
Baptist Chapel
Church Street

Baptist Chapel built in the 1890s by Messrs King on land donated by John Cox of Denham. Set some distance back from the carriageway behind a carpark and on rising ground. 19th century maps and photographs show that there were originally cottages in front of the chapel. These were later demolished to form a car park. To the rear of the Chapel is the Sunday school which may have been built at a later date. Both buildings are significant because of the contribution they make to our understanding of the social and spiritual history of the village.

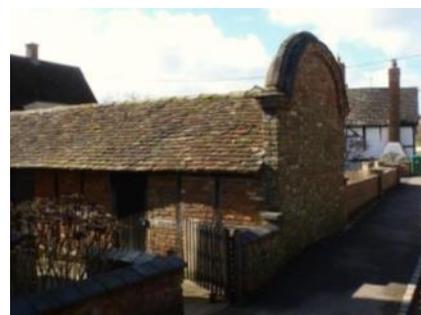
Outbuilding to Almshouses, Church Street

The outbuildings at the Almshouses on Church Street are visually distinctive structures that make a positive contribution to the street. These simple symmetrical buildings with their coved segmental gables to the street front form an important part of the Almshouses' composition.

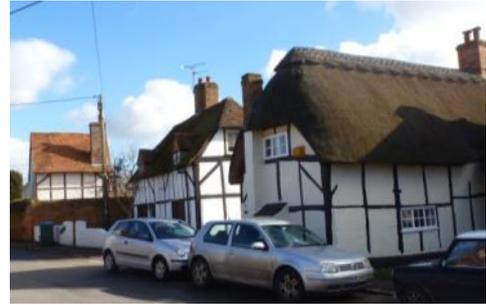
Example of timber framed cottages constructed in the box frame tradition and rendered

The majority of the medieval and post-medieval timber framed buildings surviving within Quainton are constructed in the box frame tradition, where the timber members form simple square panels. The wooden elements of many of the timber framed buildings have been blackened and the colour contrast created by the juxtaposition of these timber elements with bricks or render creates a decorative and eye-catching effect. In some cases timber framed buildings have been re-fronted or encased within brick at a later date and the timber elements are no longer visible externally.

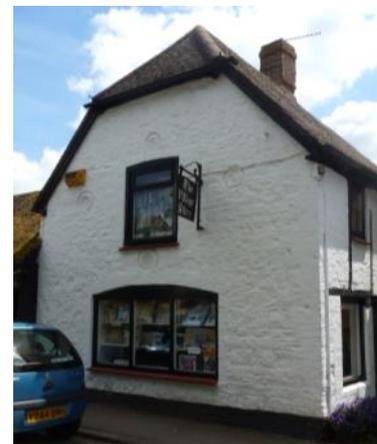
Painted rubble limestone, 6, Church Street

The rubblestone in Quainton has a greyish-white colour and a gritty texture.

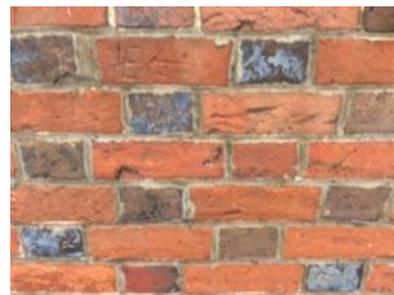
Vitrified headers create decorative variations in surface colour.

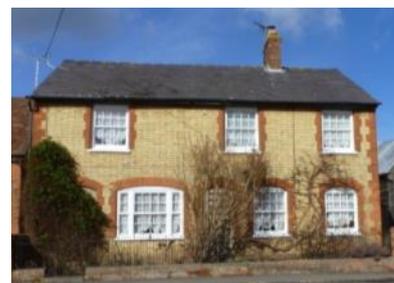
Buff coloured bricks used to emphasise string course between storeys

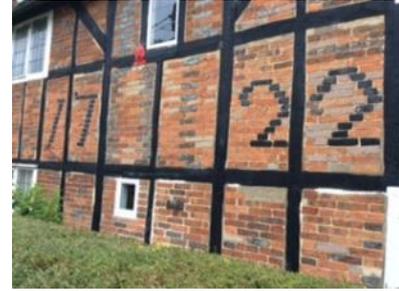
Bricks used to create date within panels on 24, Church Street

More subtle examples of brickwork used to create decorative effects include herringbone patterns within panels (although examples do exist, this is uncommon), articulation on chimney stacks, dentilated eaves, the stepped brickwork in the Baptist Chapel in Church Street and the date panels on 24, Church Street.

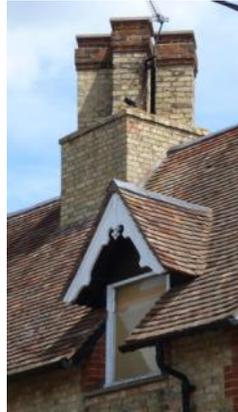
Different coloured bricks and over sailing courses create decoration on chimneys.

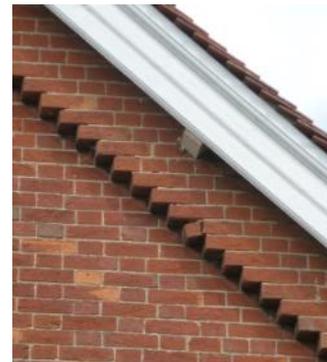
Stepped bricks on Baptist Chapel, Church Street

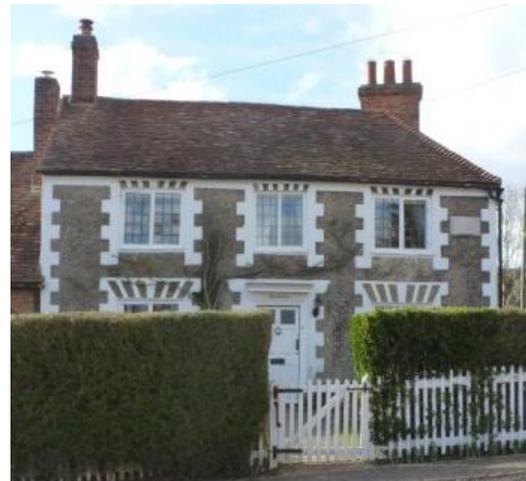
Originally the panels between the wooden members of timber framed buildings within Quinton would have been in-filled with wattle and daub. In many cases the buildings would have been rendered in a protective coat of lime mortar and limewashed. Today the majority of these infill panels have been replaced with bricks, some of which are left plain and others are rendered. The contrast of blackened timbers and the white render creates an attractive visual contrast.

11, The Green

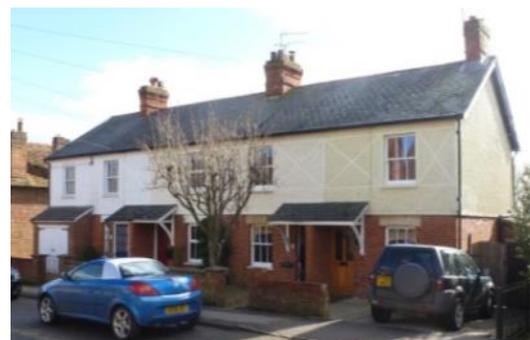
16-22, Church Street

The visual effect at 16-22 Church Street is much more subtle. Here colour contrast is achieved through the combination of plain brickwork at ground floor level and render at first floor level. In addition textural contrasts are expressed through simple smooth crosses against a background of rough render between the first floor windows.

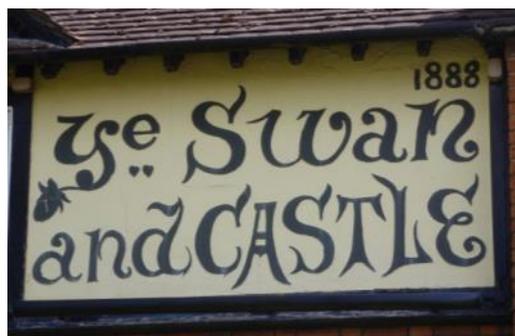
Decorative plasterwork on the Swan and Castle

The most visually striking example of the decorative potential of render is illustrated by The Swan and Castle public house on Lower Street. This late 19th century building is flamboyant in its detailing and has clearly been constructed to make a strong visual

statement that advertises the building's function. It combines timber, brick, plasterwork and render to create eye-catching colour contrasts and textural variations. Of particular note are the painted swan and castle motifs and floral swags applied to the rendered right hand (facing) gable. The irregularity of its form and quirky architectural detailing and decoration reflect the late 19th century interest in the Old English Domestic Style seen in many Rothschild buildings at neighbouring Waddesdon.

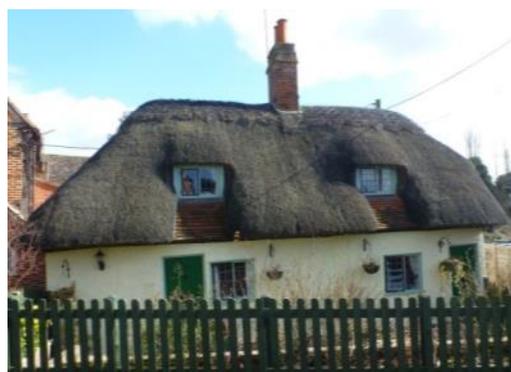
Originally the majority of pre 19th century buildings within Quainton would have had thatched roofs. Although a number of thatched roofs survive within the village, the majority have been re-laid in tile. Where thatched roofs still survive, their curved organic forms contrast with the sharp geometrical outline of tiled or slate roofs and add greatly to the visual quality of the village's street and roofscapes.

18 and 19, The Green

The traditional form of thatch in this area is long straw and ridgelines would have been plain. Changes in fashion, availability of materials and the loss of traditional skills, has meant that in more recent years the long straw tradition of thatching has been replaced with combed wheat reed or water reed. In many cases the traditional wrap over ridgelines have also been replaced with more decorative designs.

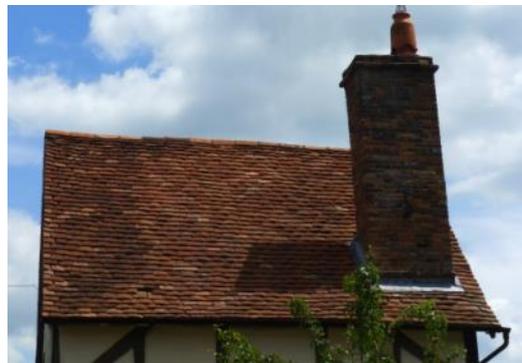
The plain tiles found on the roofs of historic buildings within Quainton are typically orangey/brown in colour, and because they are handmade, are cambered in profile and have textured surfaces. Typically handmade plain clay roof tiles are laid at 45°, but many of the tiled roofs within Quainton are laid at a much steeper pitch reflecting the fact that they have been used to thatched.

Tiled roof
1, Lower Street

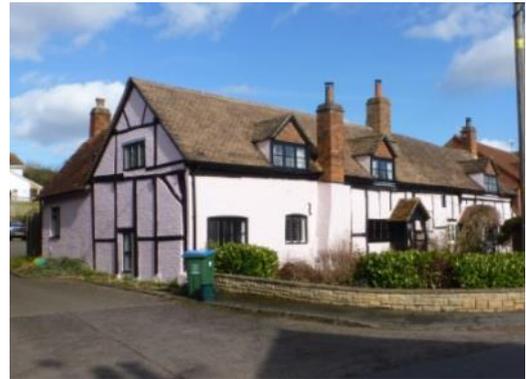
Chimneys are generally constructed in brick and vary in height. Some are plain in their detailing; others have over sailing brick courses. The majority are rectilinear in shape. Most chimneys are left un-rendered.

Examples of external, ridge and end stacks at 24 to 26, Lower Street

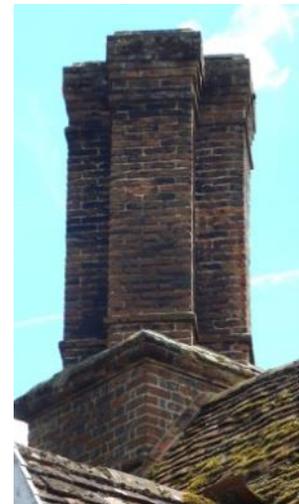
Multiple stacks, Almshouses, Church Street

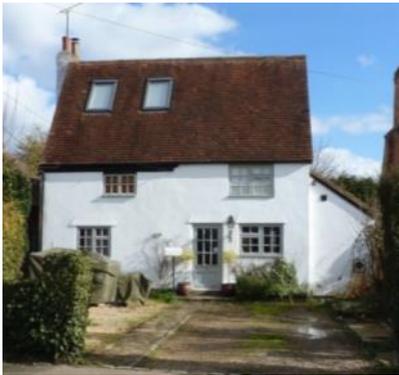
Small irregularly positioned openings typical of pre-19th century buildings

With some exceptions, the buildings within Quainton dating from or post the 19th century tend to present relatively regular fenestration patterns to the street. Those pre-19th century are generally more haphazard in the position of their windows and doors and openings are commonly small in relation to wall surface creating a strong solid to void ratio.

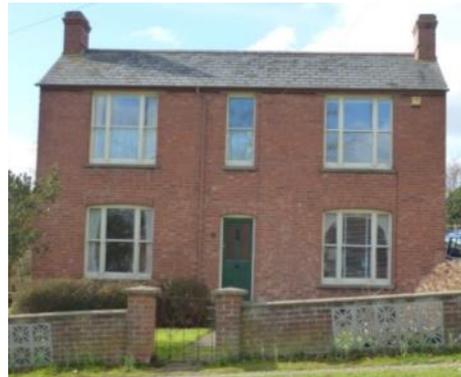
Large regularly positioned window openings typical of 19th and post 19th century buildings

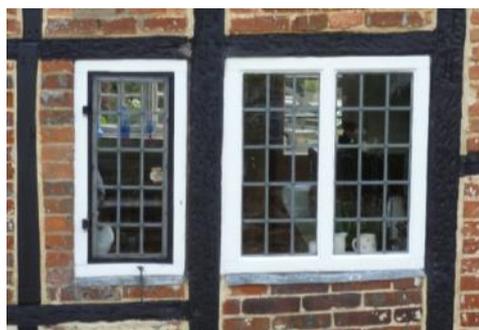
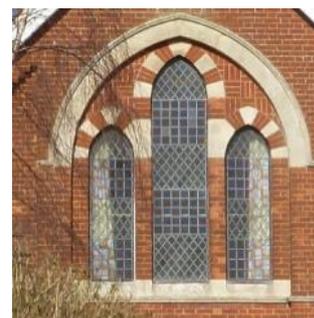
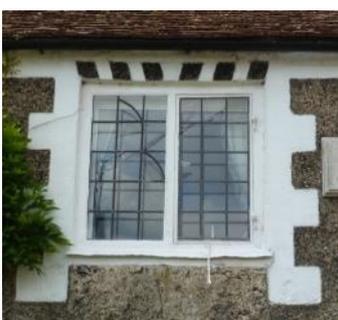
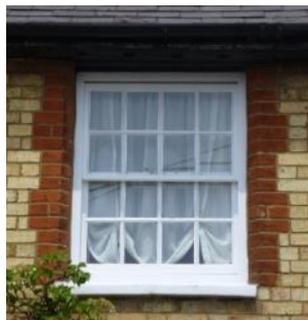
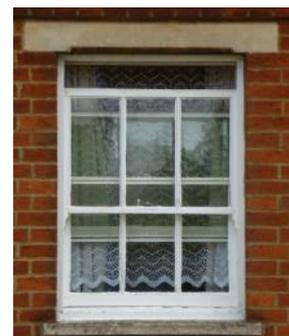
Openings within timber framed buildings in Quainton tend to be formed with simple wooden lintels often hidden beneath a layer of render. The openings of brick fronted buildings tend to be articulated with brick gauged or rubbed arches, often of a contrasting colour. As well as lintels, other elements of window surrounds can provide a vehicle for further decorative expression. Below are examples of decorative detailing around the window openings found within the Quainton Conservation Area.

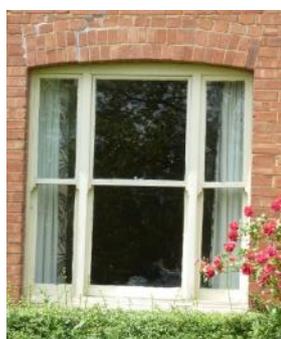
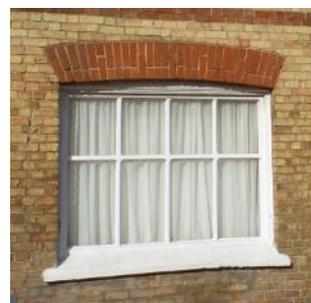
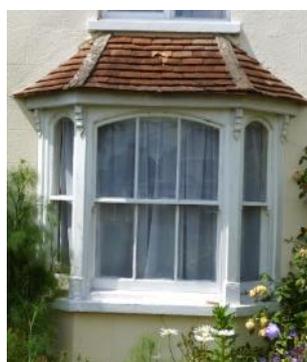
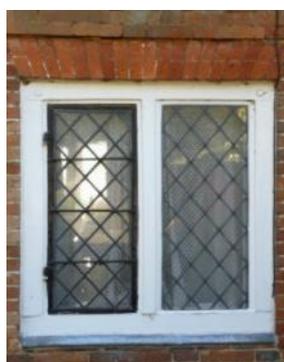
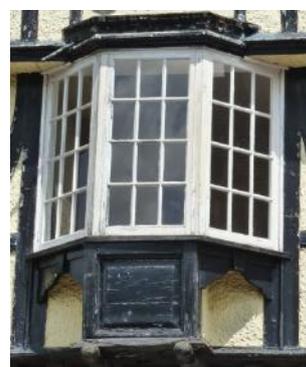
Given the range in ages of buildings in Quainton, it is unsurprising that examples can be found of most window types. There are examples of single glazed vertical sashes, metal and timber framed casements, leaded lights, lancet windows, ground single and two storey bays and oriel windows. Windows differ in their proportions; many have different combinations of opening and fixed lights and varying numbers of panes. The majority sit slightly back from the wall plane and all historic casements are flush fitting. Where windows are timber, they tend to be painted rather than stained.

Below are some photographs showing the varying types of window designs found within Quainton.

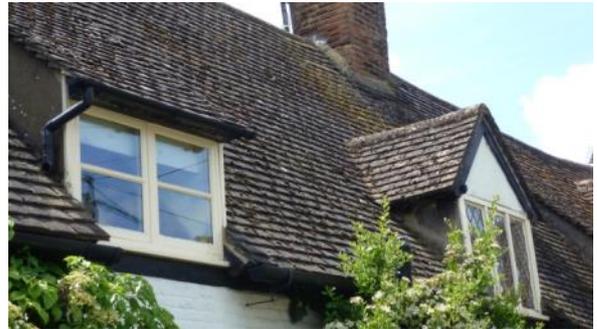
A number of historic buildings within Quinton have dormer windows within their roof planes. They are particularly common on former single storey thatched buildings where dormers provided the possibility of additional accommodation within the roof space. The dormers on these buildings tend to sit on or cut through the eaves line and would have former swept or eyebrow dormers. Today they are tiled and take the form of gabled or catslide roofs.

Examples of gabled and catslide dormers within the same roof plane.

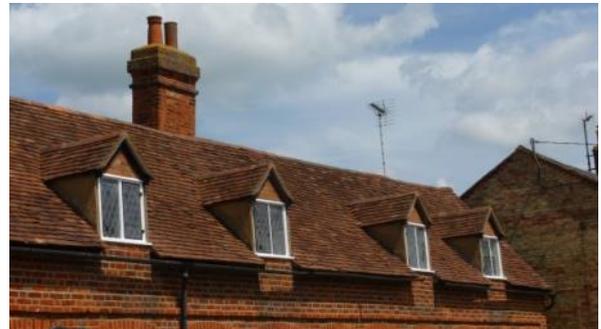
Dormers can relieve large roof planes and create a strong and rhythmical architectural statement

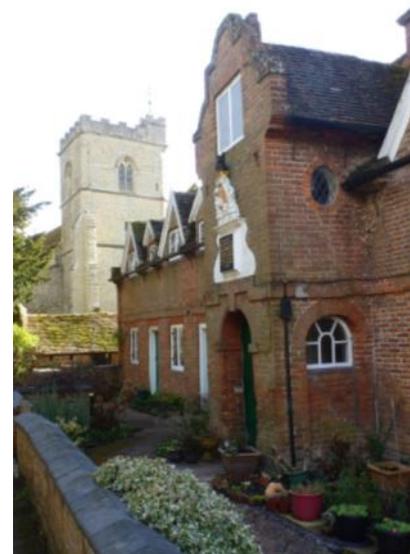
Two storey enclosed brick porch to The Almshouses, Church Street

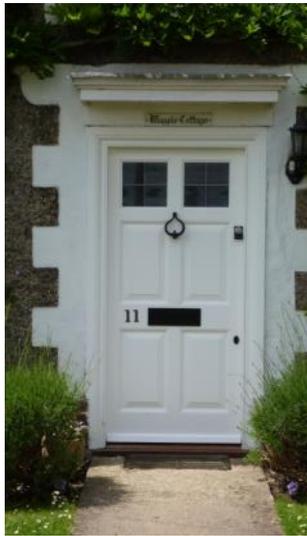
Flat canopy,
11 The Green

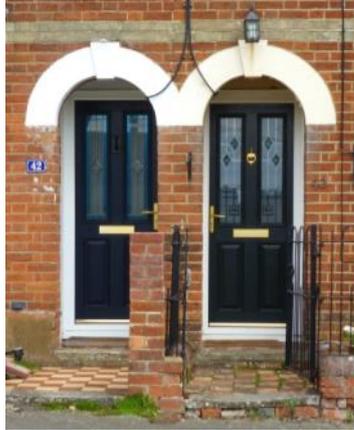
Recessed porches

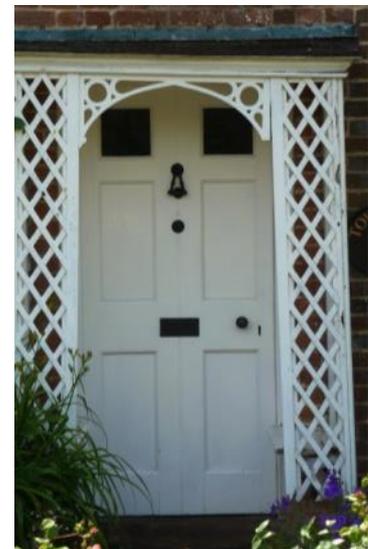
Open porch

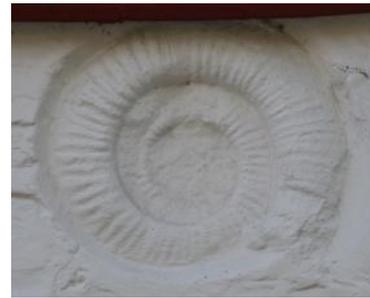
Ammonite, 6, Church Street

A number of historic buildings within Quinton are decorated with unusual and sometimes quirky details. Of particular interest are examples of old advertisement and of ammonites used to articulate the front elevation of 8 Upper Street and the gable elevation of 6, Church Street.

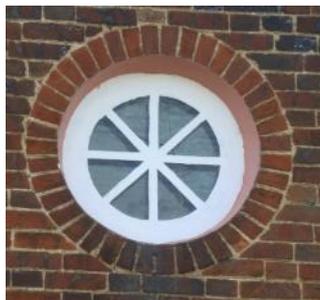
Painted blind window

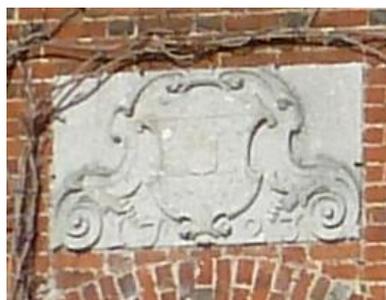
Carved heraldic motifs

At the Almshouses on Church Street and above the principal entrance to 12, The Green, heraldic motifs carved in stone or plaster have been used to acknowledge patronage or designed to reinforce social status.

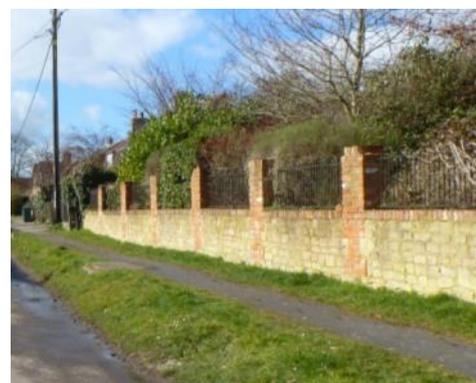
Stone and brick boundary wall to 15, Church Street

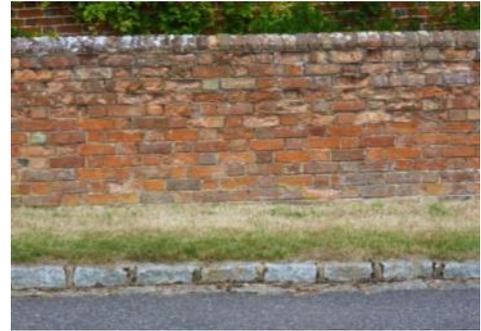
Brick boundary wall to 12, The Green

Within the village, boundaries are not a visually dominant form and tend to simply fulfil the roles of providing enclosure, maintain building lines and defining public and private space without visually dominating the streetscapes. Some fine examples of boundaries survive which form important visual foregrounds to views of individual buildings – for example, the brick boundary wall marking the frontage boundary of 12, The Green.

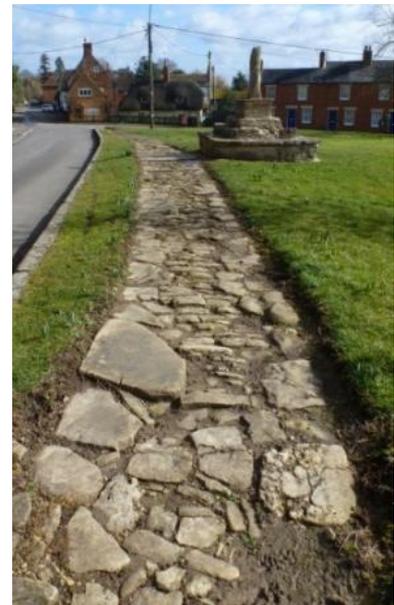
However, Quainton is fortunate to still retain some areas of traditional street surfacing which add greatly to the visual character and historic interest of the village. These areas of traditional surface material are found on a number of tracks and paths in and around the village. Within Quainton these pathways extended through the village via Lower Street, The Strand, Upper Street and Church Street. Evidence of their existence still survives, the best example being the random rubble footpath along the northern edge of The Green.

Random rubble footpath at northern end of The Green

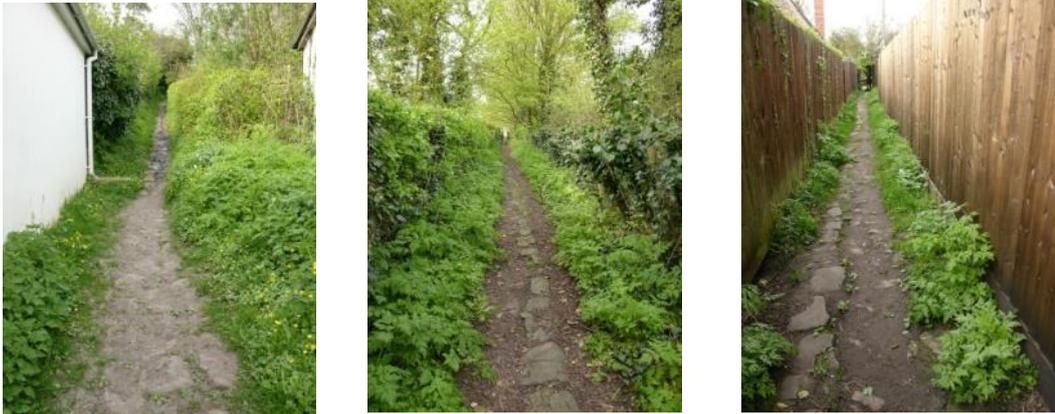
Stone footpaths within and on the peripheries of Quainton

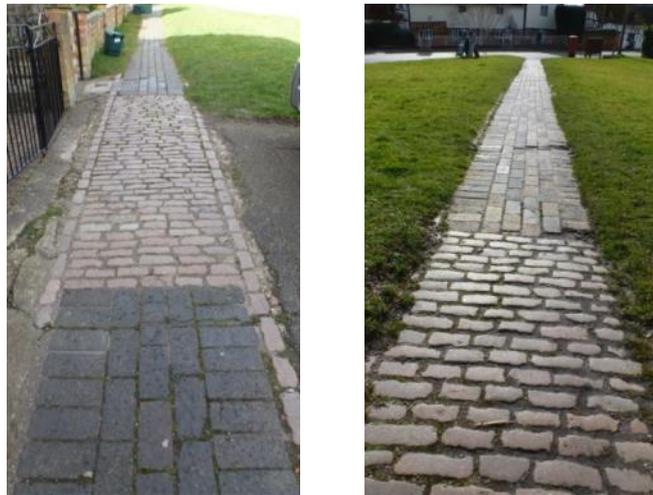
Brick and stone set footpaths across The Green

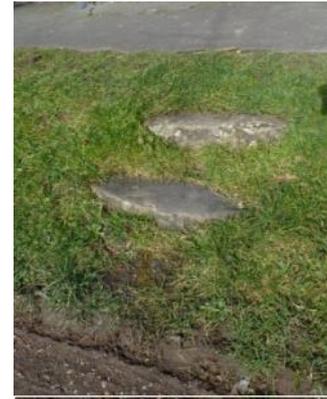
Simple stone steps imbedded into grass verge on Church Street

Other quirky details like the stone steps imbedded into the bank along Church Street add to the overall character of streets and should be recognised as making a contribution to the visual quality of the area. These features, however simple are worth preserving and play a key part in helping to establish an area's sense of place.

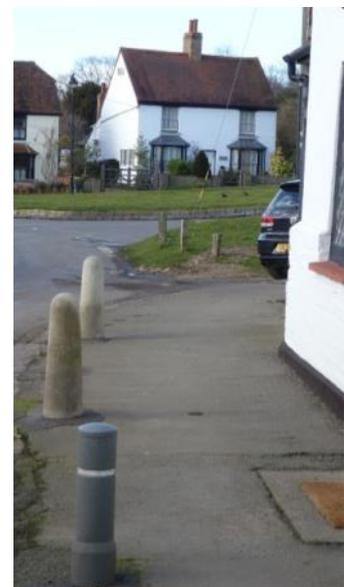
Poor quality surface to pavement, bollards and overhead cables all detract from the visual quality of The Green

- Maintain and repair surviving areas of stone and brick footpaths. These footpaths need to be recorded and plotted on a map and an analysis of their condition undertaken. It should be noted that areas of historic street surfacing may also survive beneath layers of tarmacadam. Consideration should be given whether these areas should be re-exposed or preserved in situ as archaeology. These traditional street surfaces contribute greatly to the visual and textural quality of the streetscapes. (please refer to the Aylesbury Vale, Highway Protocol)

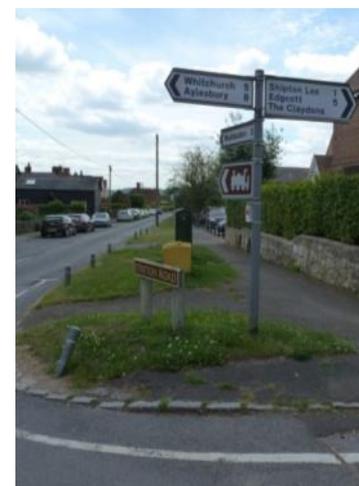
Street furniture creating visual clutter

The paraphernalia that results from modern living and in particular modern forms of transport has had a huge impact upon the visual appearance of the public realm. Traffic signs, painted road markings, bollards, noticeboards, bins and overhead cables all clutter our public spaces and often detract from the visual character and quality of the Conservation Area. While some of these items are essential, others are not and consideration should be given to undertaking a street signage and street furniture audit in order to ascertain whether there is any capacity to rationalise or improve these elements of the streetscape.

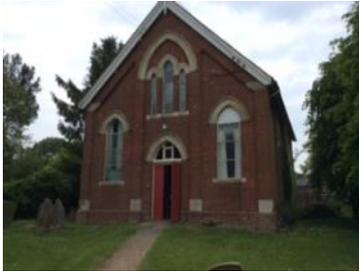
<p>Baptist Church</p>

<p>Local Heritage Asset</p>	<p>Baptist Chapel built in the 1890s by Messrs King on land donated by John Cox of Denham. Set some distance back from the carriageway behind a carpark and on rising ground. C19 maps and photographs show that there were originally cottages in front of the chapel. These were later demolished to form a car park. To the rear of the Chapel is the Sunday School which may have been built at a later date.</p> <p>Orientated so gable faces onto the carriageway. Constructed of red brick with buff brick and stone decorative detailing. One and a half storeys, the building sits beneath a steeply pitched gable roof, laid in slate. Central arched entrance door to ground floor with tripartite lancet windows above. Within the apex of the roof is a stone plaque. Two single lancet windows flank the central door and main window.</p> <p>The Baptist Chapel is an attractive building, which uses decorative architectural detailing and the contrasting colours of different materials to draw the eye. Its form and articulation is characteristic of non-conformist chapels dating from the mid to late C19. It is significant not only because of its form, architectural detailing and the positive visual contribution it makes to the streetscape (despite being set back from the carriageway), but also because of the contribution it makes to our understanding of the social and spiritual history of the village.</p>

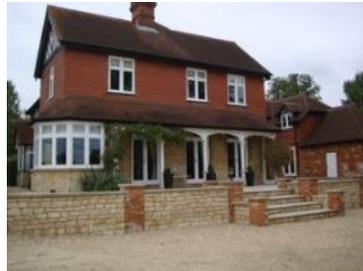
15, Church Street

Large detached house set back within its substantial grounds on land rising above the level of the carriageway. Constructed in 1901, the building is partially obscured from view by hedging. Two storeys. Main range has steeply pitched gable roof with ridgeline running parallel with the carriageway and prominent chimney stack along ridgeline. Further ranges to the rear. Applied timber creating a decorative visual effect to apex of gable of main range. Ground floor of main range constructed of rubblestone, first floor of decorative hung tile. Canted bay at corner of main range connected to open veranda which runs along the front of the property. Decorative wooden open gabled porch to rear range encloses main entrance. This building is significant because of its age and because it retains much of its original form and character as well as many of its original external features. It is a very attractive status building and forms part of a group of Edwardian properties within the village which represent a final flourish of development prior of the 1st World War.

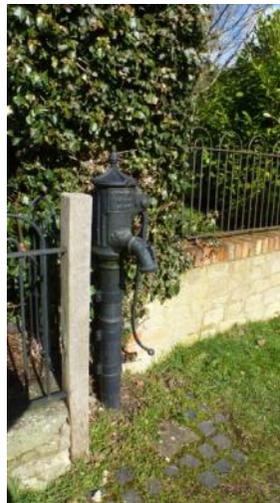
Village pump in front of 15, Church Street

C19 metal pump, complete with handle. This is an attractive structure that adds to the visual attraction of the street. It is interesting in terms of our understanding of the role water sources played in the original development of the village as well as the development of water and sanitation during the 19th and 20th centuries. This pump is one of a group of three similar pumps located throughout the village.

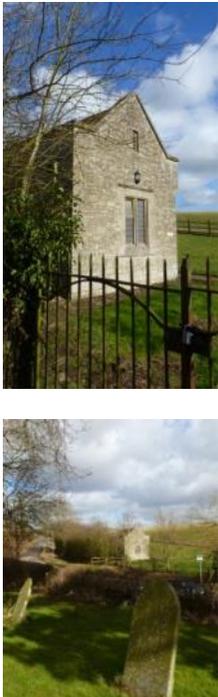
Structure	Status	Assessment of Significance
<p>Pumping station</p>

<p>Local Heritage Asset</p>	<p>Small late C19 or early C20 pump house located on the eastern edge of the village. Set slightly back from the road behind hedging, only the southern gable of the building is visible from the public domain and forms an attractive focus to views looking eastwards from the churchyard. Constructed of stone the building is single storey and sits beneath a parapet gable roof, laid in slate, the ridgeline of which runs parallel with the carriageway. The stone mullion window within the visible gable contains metal windows. Quite austere in character, this building is significant because it is an interesting example of an attractive public utility building.</p>
<p>56, Church Street</p>

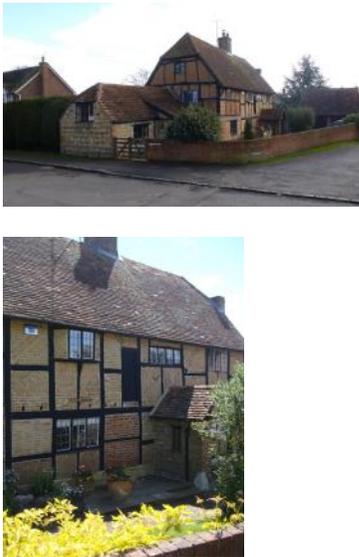
<p data-bbox="810 727 913 759">Grade II</p>	<p data-bbox="990 727 2072 1066">House. C17, altered. Timber frame with diagonal braces and brick infill, part herringbone, whitewashed and part rendered to east. Far gable and ground floor of near bay rebuilt in brick. Rubble stone plinth. Tiled roof half-hipped to front, rebuilt brick chimney between far bays. 2 storeys and attic, 3 bays. Irregular leaded casements. E. side has 2 C17 canted oriel windows on shaped wooden brackets, both with ovolo moulded wooden mullions, that to centre of first floor with blocked side lights, that to ground floor right with small tiled gable above. C17 4-light window between right bays, over lobby entry, has similar mullions. Similar 3-light window to rear. C20 door in C20 brick and tile porch. Board door to first floor at right of centre bay. Gable to street has old diamond leaded casements and single storey rubble stone extension.</p> <p data-bbox="990 1104 2072 1136">Interior: chamfered spine beams, that to centre bay stopped. Large rubble stone fireplace.</p>

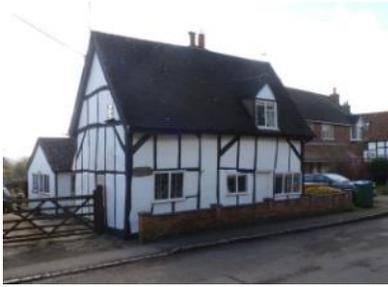
Structure	Status	Assessment of Significance
<p data-bbox="114 193 320 220">32, Church Street</p>

<p data-bbox="824 193 913 220">Grade II</p>	<p data-bbox="981 193 2078 416">House. C17, altered. Timber frame with diagonal braces and colourwashed render infill. C20 tiled roof, brick chimney to rear. L-plan. One storey and attic, 2 bays to front. Ground floor has old leaded windows: one 3-light casement in wooden architrave frame to right, and 2 paired casements. Upper floor has C20 paired leaded casement in gabled eaves-line dormer to right. 4-panelled door in wooden architrave frame between right windows. Rear wing also has C20 leaded casements. Small tiled oven projection to centre of right side. C20 single storey extension to rear.</p>
<p data-bbox="114 512 405 539">34, and 36, Church Street</p>

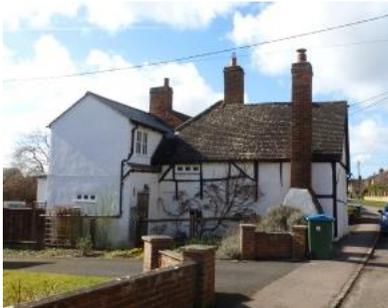
<p data-bbox="824 512 913 539">Grade II</p>	<p data-bbox="981 512 2078 699">House. C17, altered. Colourwashed render and brick, some exposed timber-framing, C20 tile roof, rebuilt brick chimneys between wings and to left side. L-plan. 1½ storeys, 2 bays, that to left projecting. Irregular paired barred wooden casements, one single light to ground floor of right gable. Board door in right side wall of left bay. C19 2-storey extension of whitewashed brick to rear has one bay of sash windows.</p>

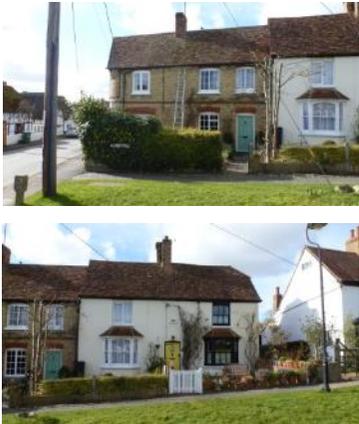
Structure	Status	Assessment of Significance
<p>1, and 2, (London House) The Green and 2, Lower Street</p>

Grade II	<p>Includes no. 2 Lower Street. 3 houses and shop. 2 bays to right are part of C17 L plan house re-fronted and extended 1882. Original building has timber framed gabled projections to rear right gable rebuilt in brick rendered front. Old tile roof half hipped to right central chimney of thin brick. 2 storeys 2 bays. Ground floor has C19 canted bay windows with segmental headed sashes. First floor has 3 pane sash to right and c20 paired wooden casement to left. Central lobby entry has door with segmental head and rendered key block. Rear has an old paired leaded casement to first floor. Late C19-C20 extension to left is of red and yellow brick with wooden casements 6-panelled door to right and shop front to left with curved corner door.</p>
<p>3, The Green</p>

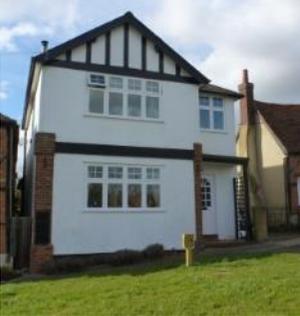
<p>8, The Green</p>

<p>Local Heritage Asset</p>	<p>C19 building situated hard up to and orientated gable onto The Green. Two storey, the building sits beneath a gabled roof. Principal gabled range with subservient parallel range set slightly back. Constructed of brick, rendered and painted with applied timber to apex of gable. GR post-box painted black integrated into left corner of building. Despite alterations to windows, this is an unassuming building which in terms of its form, scale and massing is in keeping with its historic neighbours makes a positive visual contribution to the character of The Green and The Conservation Area.</p>

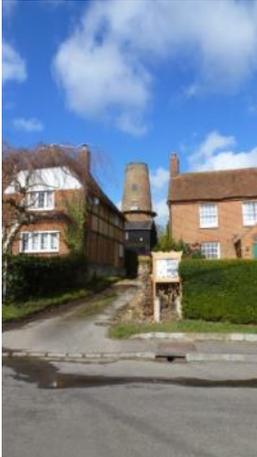
<p>Grade II*</p>	<p>1st October 2013 List Description amended and listing upgraded from II to II*</p> <p>Summary of Building: Corn windmill, tower type, built 1830-32 by James Anstiss (Miller and Farmer), restored by the Quainton Windmill Society over a period of thirty-three years.</p> <p>Reasons for Designation Quainton Windmill, a brick-built tower mill completed in 1830, is listed at Grade II* for the following principal reasons:</p> <p>Architectural interest: the windmill reflects in its design and machinery the specific function it was intended to fulfil and how it was adapted to meet changes in technology and in the economy;</p> <p>Intactness: the original mill machinery and fittings are intact and in working order;</p> <p>Rarity: it is an example of a tall six-storey windmill and is the third tallest windmill in England. It was altered to be operated by an auxiliary steam engine which unusually was placed within the structure of the mill.</p>

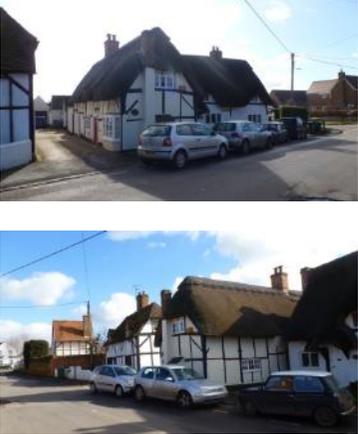
Grade II	<p>Public house. C17. Timber frame with diagonal braces and whitewashed brick infill. Half hipped thatch roof brick chimney between left bays later smaller chimney to right. 1 1/2 storeys 3 bays. Barred wooden casements : 3 light to ground floor of left bays canted bay window to right one paired casement to centre of upper storey in thatch. Board doors to right of left and centre bays. Gable to street has similar 3 light casement to first floor. C20 extensions to far gable. Interior has stop chamfered spine beams.</p>

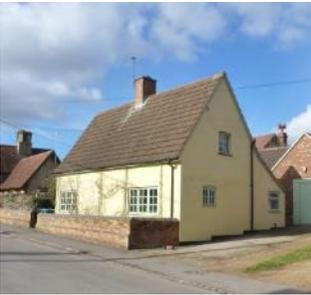
Structure	Status	Assessment of Significance
16, Lower Street

<p>Local Heritage Asset</p> <p>This simple building is prominently positioned at the front of its plot and is visually prominent within the streetscape. Despite later extensions to the rear, the simple form of the building, its steeply pitched roof (which may indicate that it was originally thatched), irregular fenestration pattern and strong solid to void ratio suggest that this building may have much early origins and therefore be of interest. The simple character of this building render it visually attractive and it forms part of a group of historic buildings found throughout the village which are small in scale and simple in form, outline and articulation.</p>
8, 10, 12 and 14, Lower Street

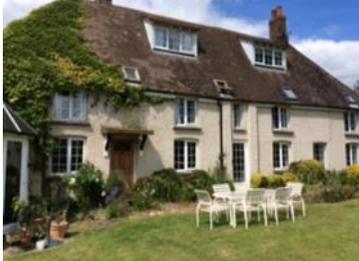
<p>Grade II</p>	<p>House. 3 C17 bays rebuilt to front remainder surrounded by C20 extensions. Original rear and end walls retain much timber framing; front wall rebuilt in brick and covered with colourwashed roughcast the ends and centre marked with pilasters. Hipped C20 tile roof 2 rebuilt brick chimneys near ends of ridge. 2 storeys and attic 3 bays with narrow extension to right and conservatory to left. C20 barred wooden casements those to ground floor with segmental heads. Attic has 2 skylights and 2 dormers. C20 doors to centre and between original left bays. The latter with flat hood on brackets. Interior has deeply chamfered spine beams to ground floor and curved wind-braces in central attic room.</p>
